II. EXAMPLES OF EARTH ELECTRODES CORROSION IN SOUTH OF CHINA

In autumn 2009 few sites of power system installations in Ghanzou (Jiangxi province) in China were visited by Galmar representatives with the aim of investigation of current state of earthing system constructed and in service in period of app. 10 years.

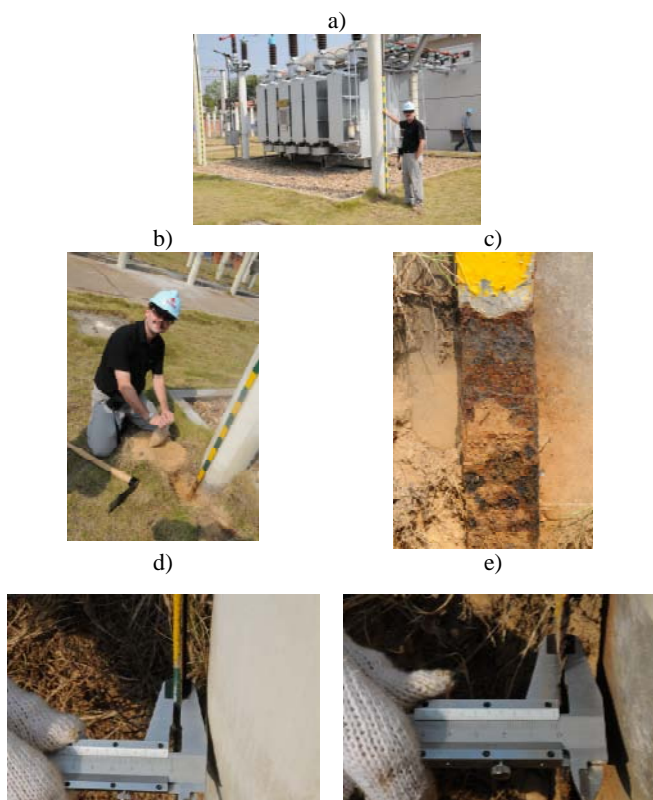
The first analysed case is shown Fig.2 and concerns the earthing conductor made of zinc galvanised steel tape having initial cross section dimensions 30 x 4 mm.

Fig.2. Pictures of 110 kV substation earth electrode inspection with significant corrosion damages after 10 years exposure in soil: a) general view of substation, b) uncovering of soil upper layer, c ÷ d) measurements of earthing tape thickness.

The part of the earthing conductor placed in soil below earth surface corroded uniformly. The comparison of the tape width above and below the soil surface, measured as shown in

Fig.2d and 2e was reduced of app. 2,5 mm, which means by app. 60%. It can be assessed that in this specific case the corrosion rate is roughly of 0,25 mm/year.

This unexpected fast degradation of earthing zinc-galvanised tape in soil is caused by electrochemical corrosion process, accelerated by local climatologic influence and soil characteristics – mainly moisture content in soil and wide variation of temperature. In case of earthing round wire the subsurface corrosion is also observed.

Based on observations and inspections of real earthing installations in Ghanzou, we suggest not to install the zinc coated steel earthing system components – mainly earth electrodes and conductors for power system in those regions of China, where the climatic conditions are similar to typical for Jiangxi province.

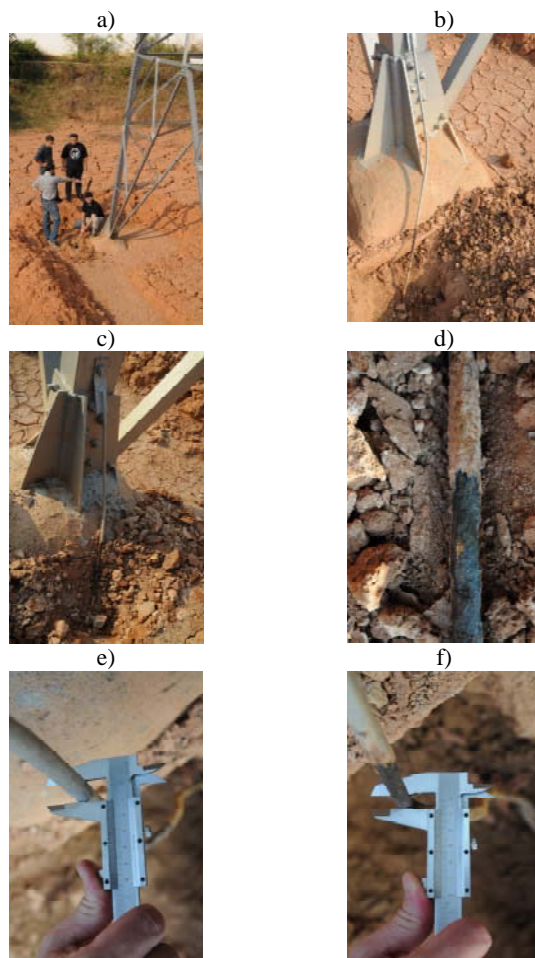
The second investigated case illustrated in Fig.3 is related to earthing system of 220 kV overhead transmission line tower.

Fig.3. Pictures of 220 kV transmission line tower earth electrode inspection with significant corrosion damages after 10 years exposure in soil: a) general view of tower leg, b), c) earthing conductors of tower earthing system, d) details of corroded earthing solid round conductor, e) measurements of earthing conductor diameter.

In this case also the part of the steel zinc galvanised round earth conductor corroded uniformly in soil below the earth surface. The comparison of the conductor diameter above and below the soil surface, measured as shown in Fig.3e and 3f, shows reduction of this diameter of app. 3 mm comparing initial value 12 mm above the ground. It can be assumed that in this specific case the corrosion rate is roughly of 0,15 mm/year radial.

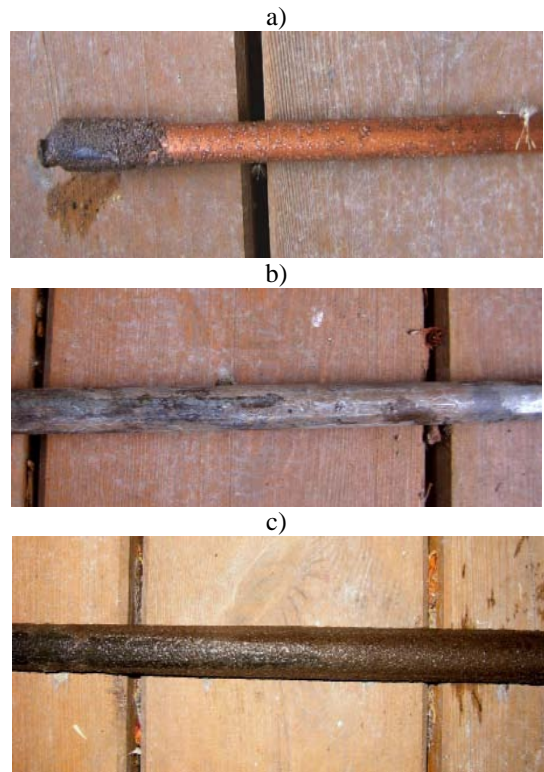
Copper coated earth rods embedded in both sites in the upper part (0,5 to 1,5 m from the earth surface) were covered with corrosion deposits joined with original soil, which were well adherent to the rod surface embedded. The lower part of rod had no visible corrosion centres neither after two nor after four years of exposure in soil (see Fig.5 and 6).

The earth rods with zinc galvanised coating installed in both sites were covered with corrosion products along their

whole lengths. The thickness of coatings was much less than the initial one (see Table IV). When removing the steel with electrodeposited zinc coatings rods after 6 years it was seen that zinc coating was completely damaged by corrosion.

Fig.5. The exemplary pictures of rod fragments directly after removal from the soil in site A - Mielno, after six years exposure: (a) - copper coating, (b) zinc galvanised coating, (c) - zinc electrodeposited coating.

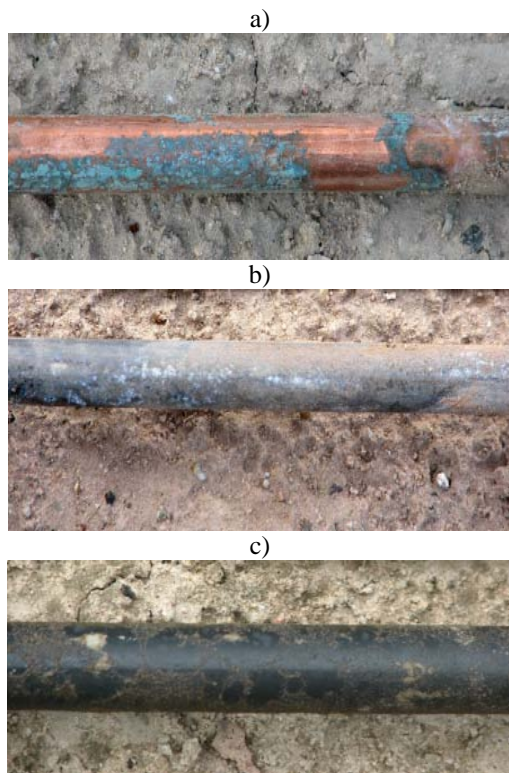
Fig.6. The exemplary pictures of rod fragments directly after removal from the soil in site B – Inowroclaw, after six years exposure: (a) – copper coating, (b) zinc galvanized coating, (c) – zinc electrodeposited coating.
