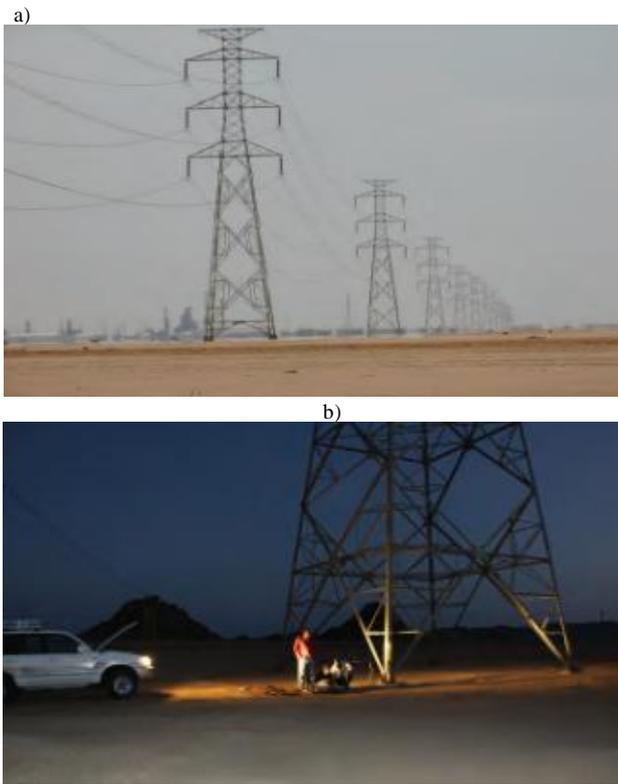
All field measurements have been done in the vicinity of the tower no. 31 of 220 kV transmission line "Al-Gaili to Shendi" (Fig.2).

Figure 2. General view (a) and tower nr 31 (b) at investigated site.

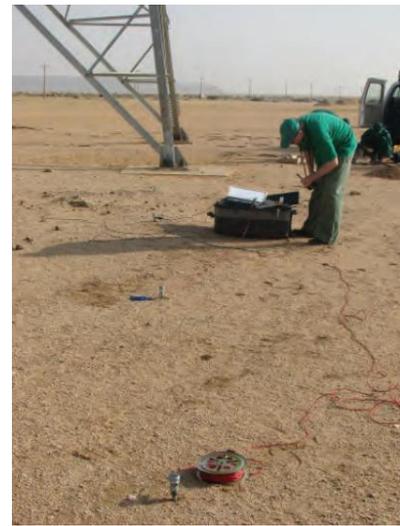
The soil resistivity was measured in close distance from the tower using four electrodes (Wenner) method and meter Megger as shown in Fig.3. The distances between electrodes were varying from 1 to 3 m.

Figure3. Measurement of soil resistivity in the vicinity of the tower no. 31.

1. During the corrosion field test campaign in investigated site in Sudan in 2010 the soil resistivity was varying in range of 300 – 750 Ω·m in depth of 1- 3 m below the ground surface.

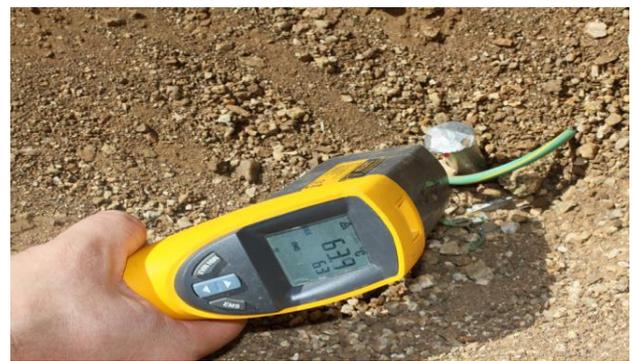
The soil and air temperature and air humidity have been measured using the digital multimeter (Fig.4).

Figure 4. Measurement of temperature of the soil – the reading was 63,9° C.

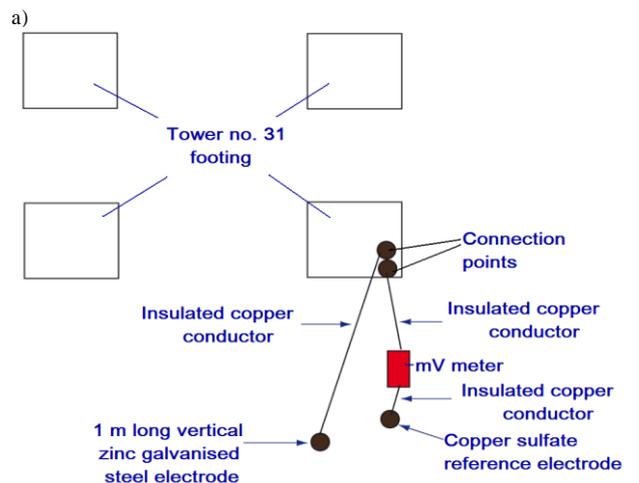
The electrochemical potential was measured using the setup consisting of digital milivoltmeter and reference electrode made of copper sulphate. The configuration of the electrochemical potential measurement system is shown in Fig. 5 and 6 [3].

Figure 5. Lay-out of electrochemical potential measurement system.

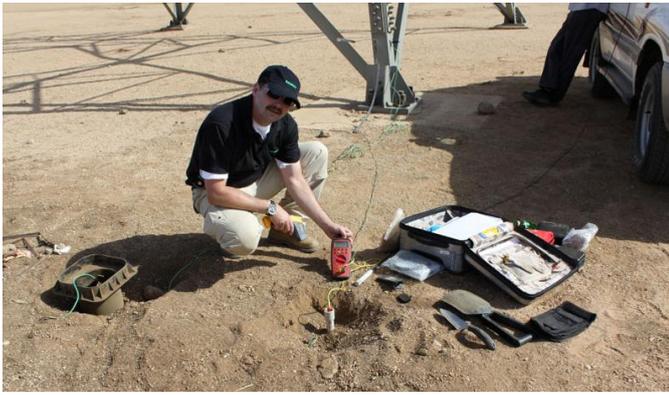
Figure 6. Picture of electrochemical potential measurements.

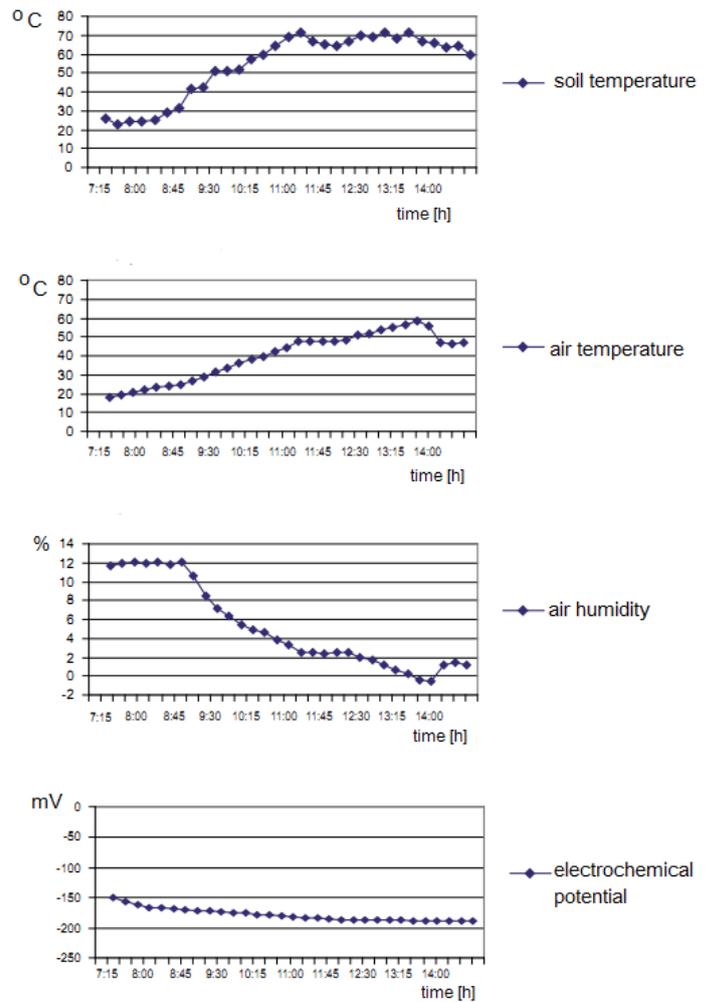
2. The results of continuous and simultaneous measurements of soil and air temperature, air humidity and electrochemical potential performed at investigated site in Sudan on March 3<sup>rd</sup> 2010 are shown in Fig.7. There have been observed very high variation of each climatic parameter during daytime while the electrochemical potential changes were relatively slow decreasing accordingly to the increase of soil and air temperature.

It should be noticed that the night temperatures of air and soil are much more lower than during the daytime and during the time of campaign in investigated site were not higher than few centigrades of Celsius.

Figure 7. The results of continuous and simultaneous measurements of soil and air temperature, relative air humidity and electrochemical potential.

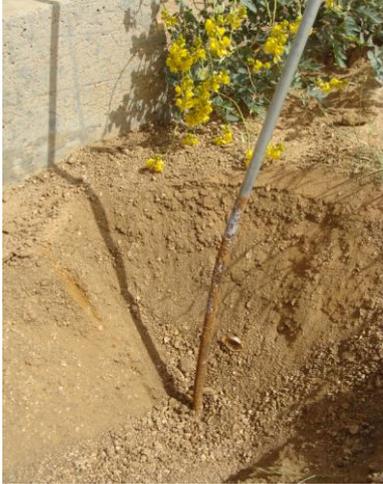
Typical examples of zinc galvanized steel corroded elements imbedded in soil are shown in Fig. 8,9 and 10.

Figure 8. Part of round zinc galvanized steel earth conductor after 6 months service (partially embedded in soil).

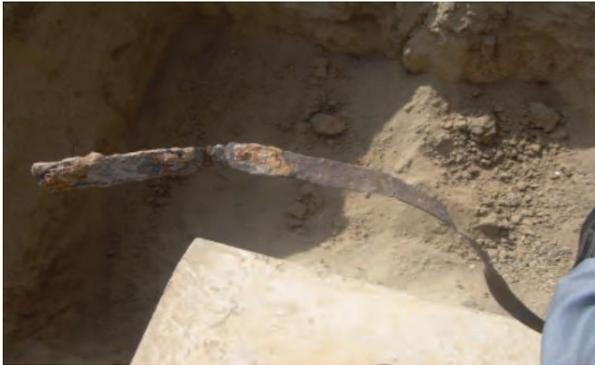
Figure 9. Part of solid zinc galvanized steel tape creating the ring earth electrode around the 220 kV transmission line tower foot after 4 years service in soil.

In the case of earth electrodes performance in Sudan - soil resistivity in the range from 300 to 750 ohm and air humidity near the ground surface close to 0% during the daytime - it was found out that for these commonly considered as favorable from point of view of protection against corrosion conditions the galvanized tape after 4 and 6 years almost completely corroded (Fig.9 and 10).

When analyzing the zinc coated steel earth electrodes performance in Sudan one can assume that there is possible the occurrence of the mechanism causing the change of the electrochemical potential of zinc coating to the potential of bare steel (steel becomes the anode). It is the effect of a very high air and soil temperature

increase and daily changes. They can play role as an additional catalyst increasing the intensity of corrosion process in soil and influencing the significant increase of its rate. The higher changes of soil temperature of the faster is the higher corrosion intensity of galvanized steel earth electrodes embedded in soil.

The authors suggest to consider to introduce the recommendations for corrosion tests of buried in soil LPS components introducing the factors taking into account the influence of climatic conditions, such as soil resistivity (or water content in the soil) and the

temperature changes adequate to different regional climate conditions.

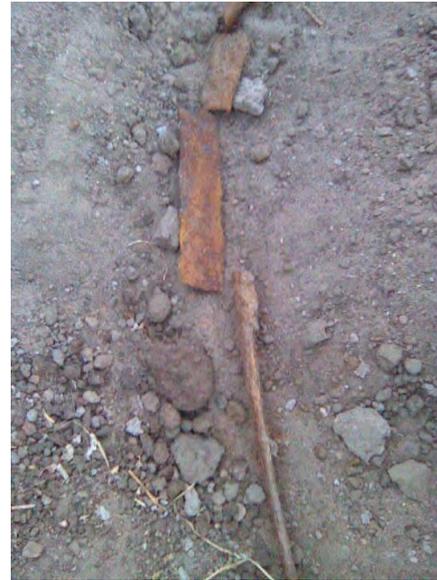
Figure 10. Part of solid zinc galvanized steel tape of the 110 kV transmission line tower earth electrode after 6 years service in soil.
