II. EXAMPLES OF EARTH ELECTRODES CORROSION IN SOUTH OF CHINA

In autumn 2009 few sites of power system installations in Ghanzou (Jiangxi province) in China were visited by Galmar representatives with the aim of investigation of current state of earthing system constructed and in service in period of app. 10 years.

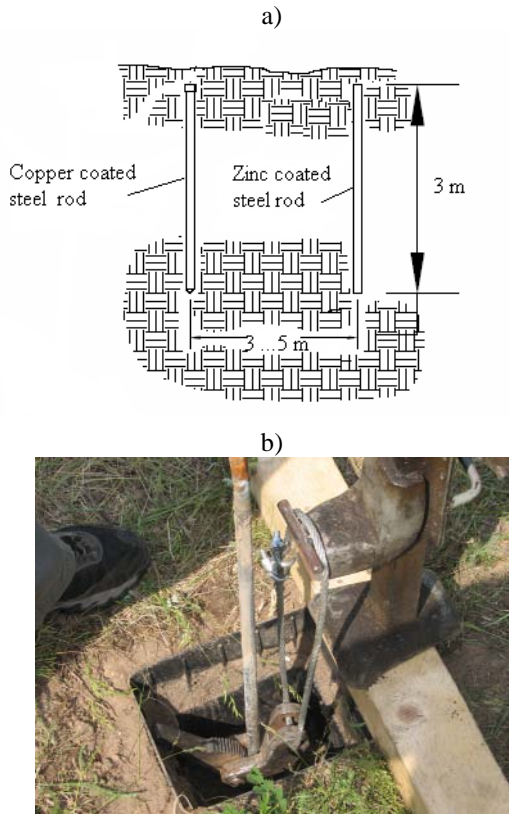
surface. The rods were installed using pneumatic hammer. Exhumations were done with a pulling out machine as shown in Fig.4. Care was taken in each case to exhume a sample without destroying the earth electrode.

Fig.4. Representation of installed conditions (a) and exhumation of zinc galvanised steel rod (b).
